REPORT
PHASE 1 HYDROGEOLOGIC EVALUATION
PROPOSED GOLF COURSE WELL SITE
CITY OF ROCK ISLAND
ROCK ISLAND, WASHINGTON

FEBRUARY 25, 2009

File No. 16399-001-03

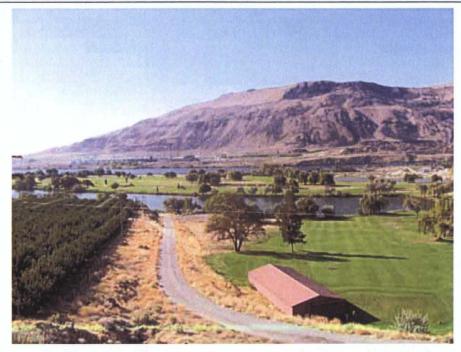
Looking south from adjacent road toward former burn site reportedly located between tree in center of photo and gravel turn-around visible near water

A representative of GeoEngineers completed a visual reconnaissance of the subject area surrounding the proposed new well site on September 9, 2008. Whitey Evenhus, Rock Island City Councilman and former Mayor, accompanied our representative during the reconnaissance. The approximate locations of the features observed during our site reconnaissance and discussed in this section are shown in Observed Features, Environmental Review, Figure 2. Selected photographs of the review area are presented in Site Photographs – September 2008, Figure 3 and Figure 4.

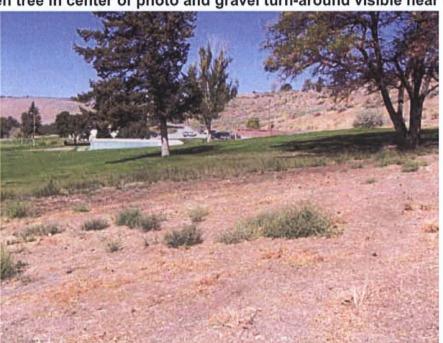
Looking west toward golf course clubhouse former burn site reportedly located in photo foreground

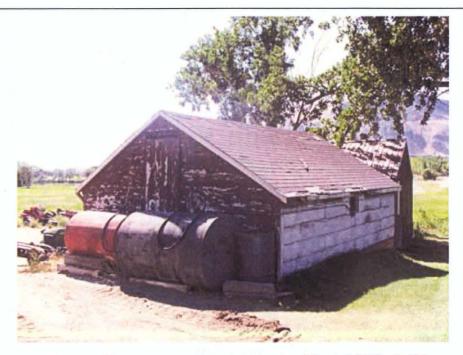
Looking south at golf course maintenance shed fuel ASTS visible; reported UST formerly located along white wall of shed

- Although no release has been identified, the existing golf course maintenance shop and two ASTs located southwest of the proposed well site present a potential source of contamination. However, because of the good housekeeping practices observed on-site and the fact that releases from these sources (if any) would likely impact only surface soils, the risk for migratory contamination from this source is low at this time, in our opinion.

- Although no release has been identified, we consider the possible presence of an UST located at
  the golf course maintenance shop as a potential source of contamination. Leaks or other releases
  from UST systems are common sources of soil and groundwater contamination. Few details
  regarding this UST have been identified and no reports regarding UST removal or excavation
  sampling activities are available.

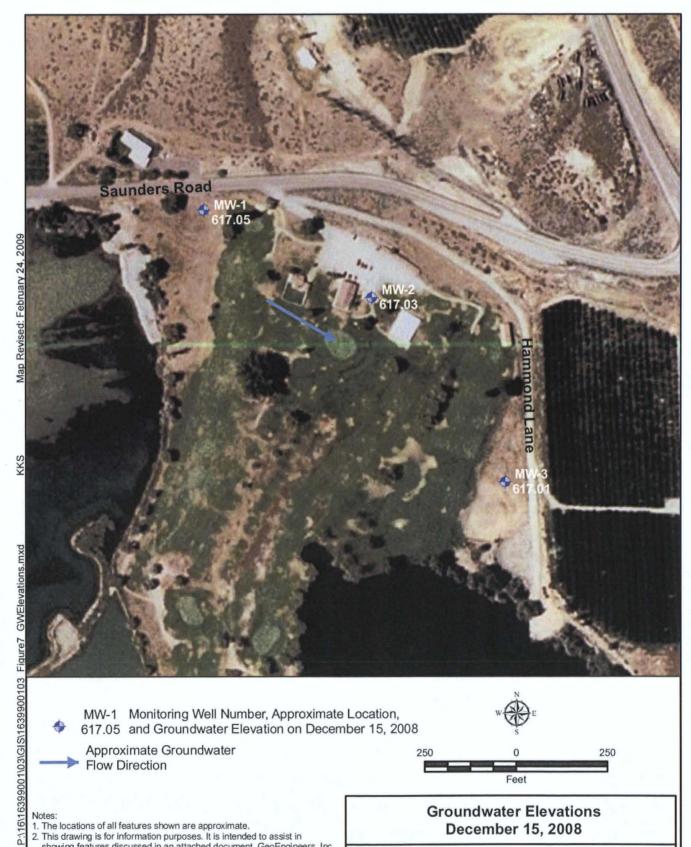
MW-1 Monitoring Well Number, Approximate Location, 617.05 and Groundwater Elevation on December 15, 2008

Soil and groundwater conditions were explored by drilling three soil borings, designated MW-1 through MW-3, at the approximate locations presented in Monitoring Well Locations, Figure 6. The purposes of the borings were to define hydrostratigraphic and groundwater quality conditions within the glaciofluvial aquifer 1) at the proposed new well site (MW-1), 2) at the suspected dump site (MW-3), and 3) about 400 feet northwest of the suspected dump site (MW-2).

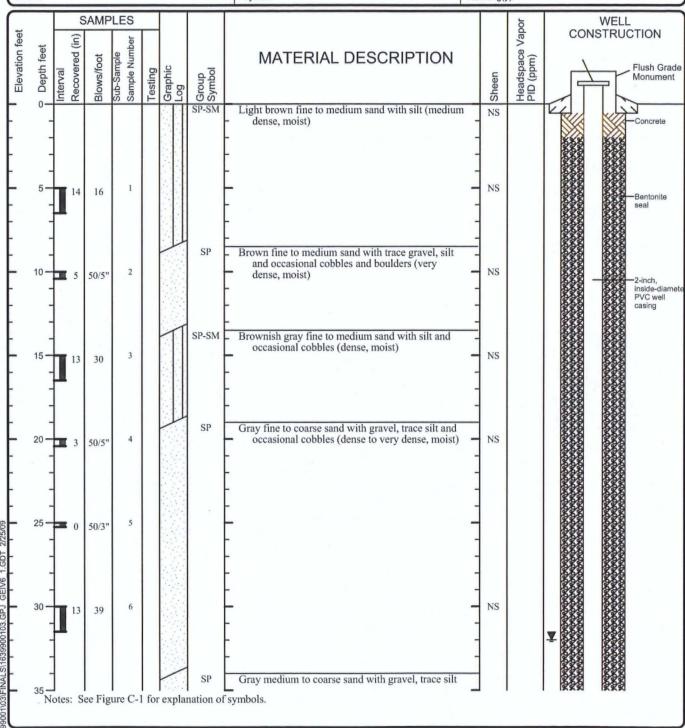
Figure: C- 2 Sheet 1 of 3

Date(s) Drilled	12/02/08 - 12/03/08	Logged By	LMS	Checked By	DRL
Drilling Contractor	Gregory Drilling	Drilling Method	Hollow-Stem Auger/Mud Rotary with Casing Advance	Sampling Methods	SPT
Auger Data	4½-inch ID Auger/4½-inch ID Casing	Hammer Data	140 lb hammer/30 in drop	Drilling Equipment	CME 85
Total Explora Depth (ft)	ation 101	Ground St Elevation	Not measured	Groundwater Level (ft. bgs)	32
Vertical Datum		Datum/ System		Easting(x): Northing(y):

#### **LOG OF MONITORING WELL MW-1**

We observed the glaciofluvial aquifer at each of the three boring locations where it is unconfined. During drilling operations, we encountered the water table associated with the glaciofluvial aquifer at depths of about 32 feet in MW-1, 38 feet in MW-2, and 29 feet in MW-3. Given these depths to the groundwater table and approximate depth to the bottom of the glaciofluvial sediments, we estimate an aquifer thickness that ranges from about 36 feet at MW-3 to at least 69 feet at MW-1.

Two-inch PVC monitoring wells were installed within each of the three borings. Each monitoring well was screened across portions of the glaciofluvial aquifer. Monitoring well MW-1 was screened from a depth of about 75 to 95 feet to enable monitoring of groundwater quality conditions within the lower aquifer, in which proposed test/production well would most likely be screened. Monitoring wells MW-2 and MW-3 were screened across the groundwater table, at depths of about 35 to 55 feet and about 25 to 45 feet, respectively. These two monitoring wells are designed to enable monitoring of groundwater quality conditions within the upper portion of the glaciofluvial aquifer, which is most likely to be impacted through infiltration of contamination associated with the suspected dump site.

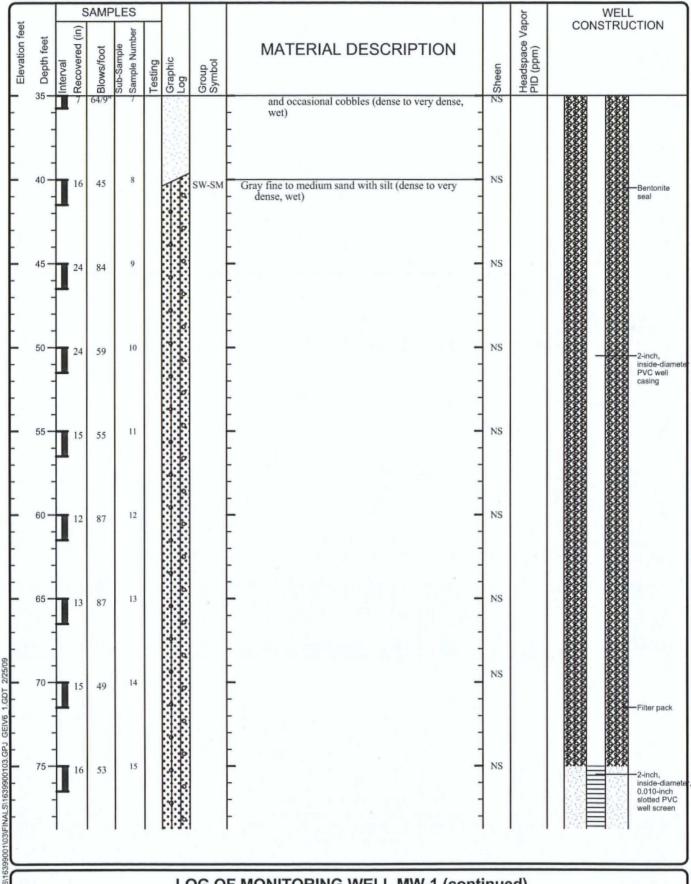
Project Number: 16399-001-03 Figure: C- 2 Sheet 2 of 3

### LOG OF MONITORING WELL MW-1 (continued)

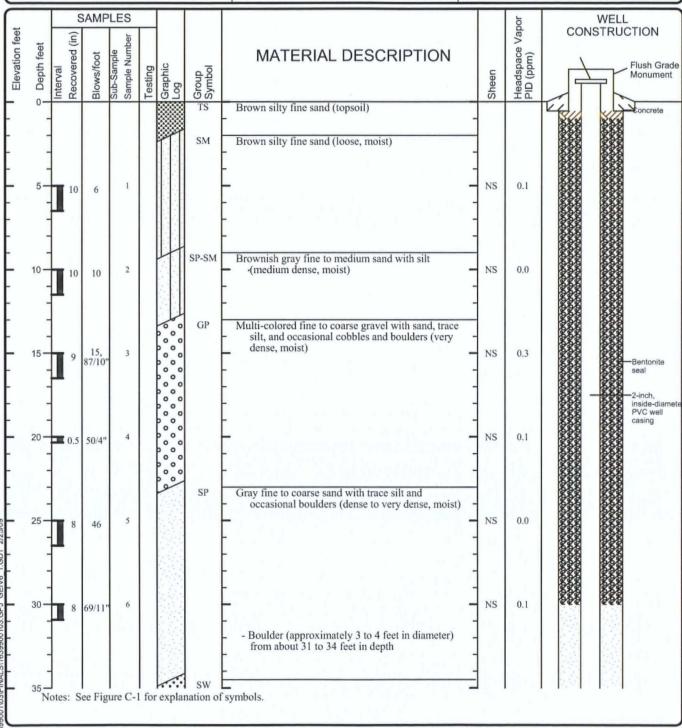
Project Number: 16399-001-03 Figure: C- 3
Sheet 1 of 2

Date(s) Drilled	12/04/08 - 12/05/08	Logged By	LMS	Checked By	DRL
Drilling Contractor	Gregory Drilling	Drilling Method	Mud Rotary with Casing Advance	Sampling Methods	SPT
Auger Data	4½-inch ID Casing	Hammer Data	140 lb hammer/30 in drop	Drilling Equipment	CME 85
Total Exploration Depth (ft)	75.5	Ground Surface Elevation (ft)	Not measured	Groundwater Level (ft. bgs)	38
Vertical Datum		Datum/ System		Easting(x): Northing(y):

#### **LOG OF MONITORING WELL MW-2**

The surficial silty sand unit only was encountered in boring MW-2, consisted of brown, silty fine sand, and extended to a depth of about 9 feet below ground surface at our boring location. The glaciofluvial sand and gravel unit was present at each boring location, and consisted of variably-colored sand and gravel with less than about 12 percent fines (silt- and clay-sized soil particles passing the U.S. No. 200 sieve), and occasional cobbles and boulders. We observed the glaciofluvial sand and gravel to depths of at least 101 feet in boring MW-1 and 75½ feet in MW-2, where these borings were terminated. We encountered glaciofluvial sand and gravel to a depth of about 65 feet in boring MW-3, where it was underlain by dark gray, vesicular, relatively unweathered basalt.

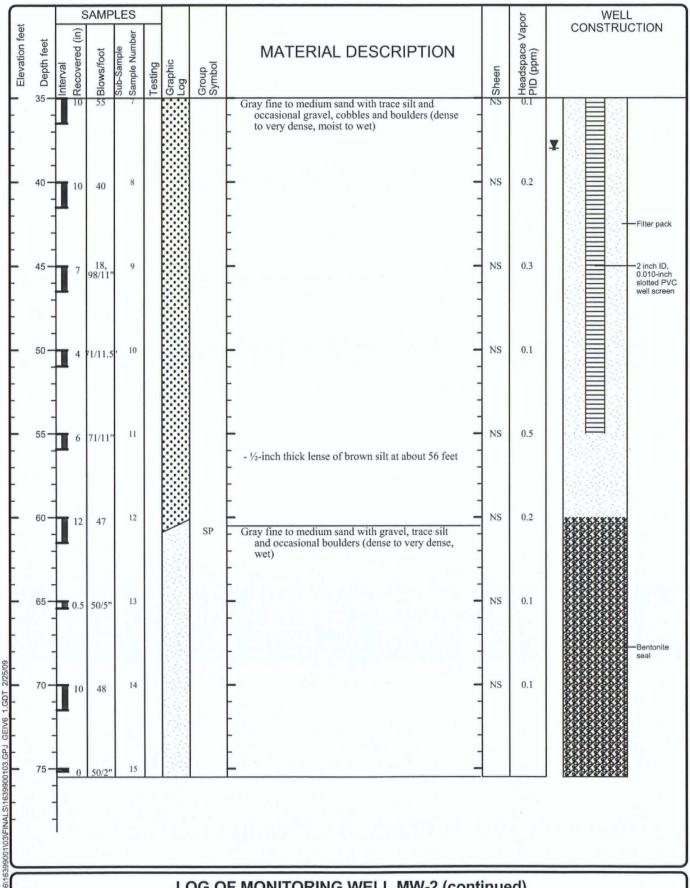
Figure: C-3 Project Number: 16399-001-03 Sheet 2 of 2

### LOG OF MONITORING WELL MW-2 (continued)

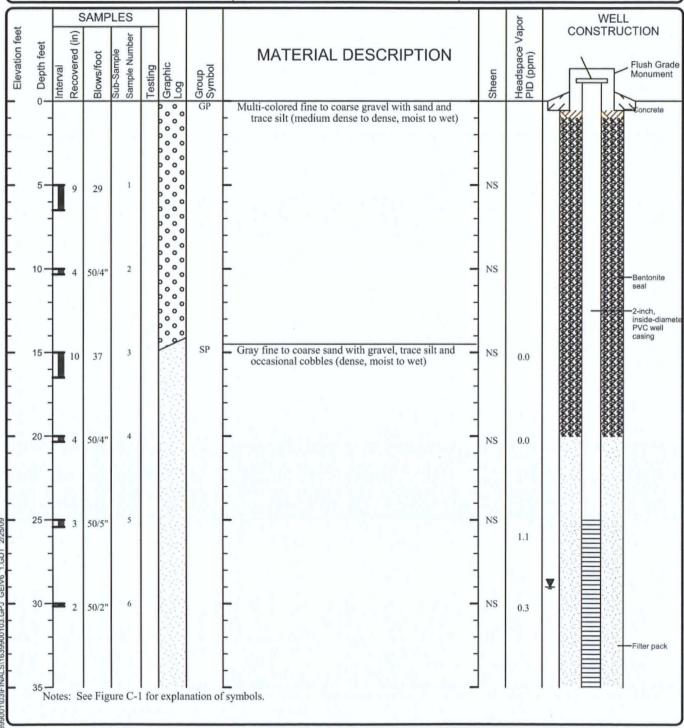
Figure: C- 4 Sheet 1 of 2

Date(s) Drilled	12/06/08	Logged By	KC	Checked By	DRL
Drilling Contractor	Gregory Drilling	Drilling Method	Hollow-Stem Auger/Hq Rock Core	Sampling Methods	SPT
Auger Data	4½-inch ID Auger	Hammer Data	140 lb hammer/30 in drop	Drilling Equipment	CME 85
Total Exploration Depth (ft)	75	Ground Surf Elevation (ft	Not measured	Groundwater Level (ft. bgs)	29
Vertical Datum		Datum/ System		Easting(x): Northing(y):

### LOG OF MONITORING WELL MW-3

No visual evidence or sheen was observed during screening of samples collected from boring MW-3. However, PID measurements ranged from 4.8 to 22.3 parts per million (ppm) in soil samples collected from about 50 to 65 feet below ground surface in this boring. These measurements could be indicative of the presence of volatile organic compounds in soil and/or groundwater. The presence of volatile organic compounds in groundwater at this location was tested by sampling and laboratory analysis, the results of which are described in the *Groundwater Quality* section of this report.

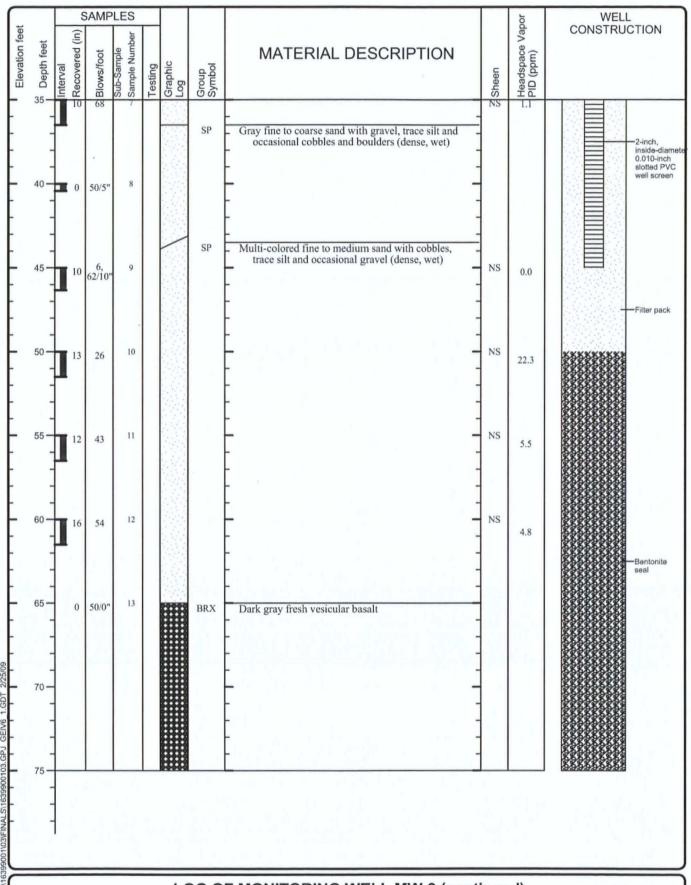
Figure: C- 4 Sheet 2 of 2

### LOG OF MONITORING WELL MW-3 (continued)

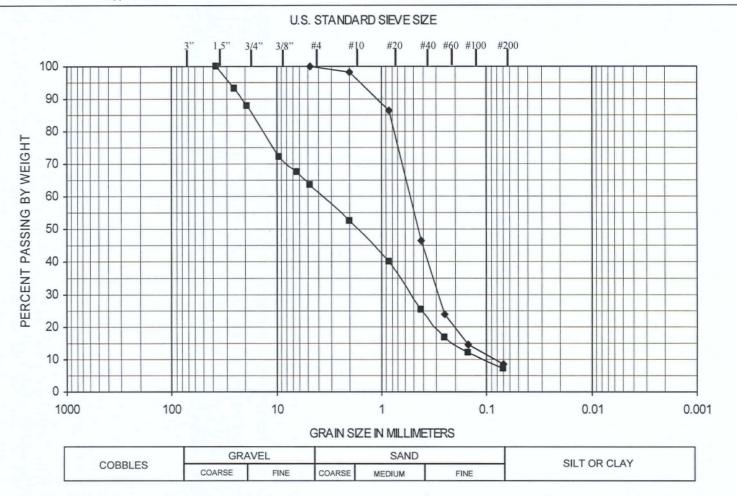
Figure C-5

SYMBOL	EXPLORATION NUMBER	SAMPLE DEPTH (FEET)	SOIL CLASSIFICATION
•	MVV-1	70	Fine to medium sand with silt
	MVV-1	90	Fine to medium sand with gravel and silt

A total of four soil samples were submitted to GeoEngineers' laboratory for analysis of grain-size distribution per ASTM Method C 136 and moisture content by ASTM Method D2216-90. Descriptions of GeoEngineers' field exploration equipment and procedures, exploration and monitoring well construction logs, and results of laboratory testing are provided in Appendix C.

- An aquifer hydraulic conductivity of 55 feet per day (ft/d), based on analysis of the grain-size distribution data provided in Appendix C.
- An aquifer thickness of 90 feet, based on subsurface conditions encountered in boring MW-1.
- An aquifer storativity of 0.2 (which is a dimensionless parameter), based on typical values for unconfined sand and gravel aquifers.
- The aquifer was assumed to be unconfined, homogeneous, isotropic, of infinite areal extent, and without boundary conditions.

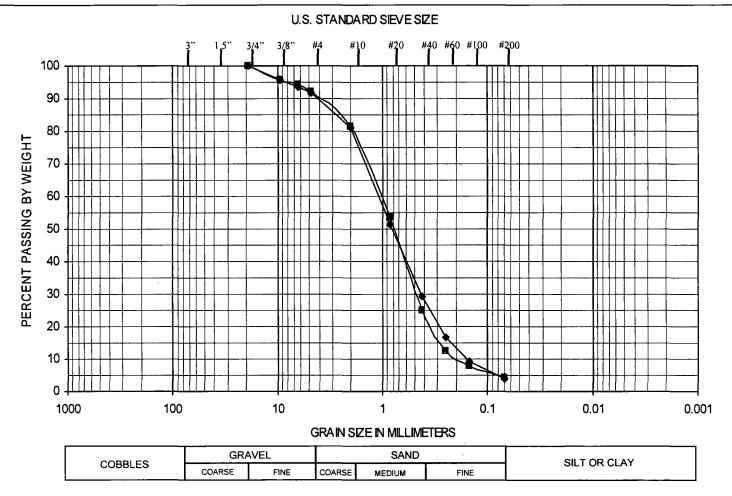
SYMBOL	EXPLORATION NUMBER	SAMPLE DEPTH (FEET)	SOIL CLASSIFICATION
<b>*</b>	MVV-2 MVV-3	40 50	Fine to medium sand with trace silt and occasional gravel Fine to medium sand with trace silt and occasional gravel

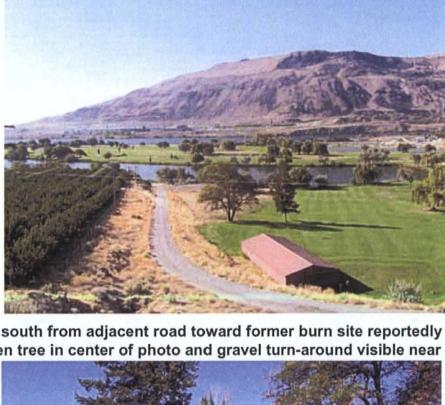
Looking south from adjacent road toward former burn site reportedly located between tree in center of photo and gravel turn-around visible near water

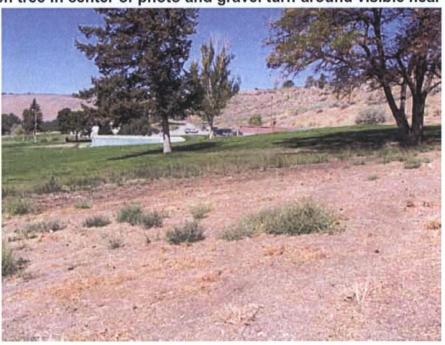
Looking west toward golf course clubhouse former burn site reportedly located in photo foreground

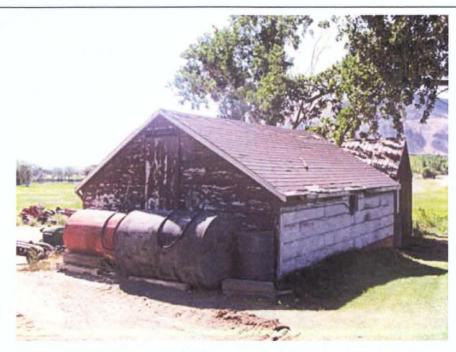
Looking south at golf course maintenance shed fuel ASTS visible; reported UST formerly located along white wall of shed
